DEPARTMENT OF TRANSPORTATION

Contract #: 04-0120F4Cty: SF/ALA Rte: 80 PM: 13.2/13.9File #: 69.28**WELDING INSPECTION REPORT****Resident Engineer:** Pursell, Gary**Address:** 333 Burma Road**City:** Oakland, CA 94607**Report No:** WIR-003587**Date Inspected:** 21-Jul-2008**Project Name:** SAS Superstructure**OSM Arrival Time:** 700**Prime Contractor:** American Bridge/Fluor Enterprises, a JV**OSM Departure Time:** 1500**Contractor:** Zhenhua Port Machinery Company, Ltd (ZPMC), Changxing Island **Location:** Shanghai, China**CWI Name:** Sun Wei**CWI Present:** Yes No**Inspected CWI report:** Yes No N/A**Rod Oven in Use:** Yes No N/A**Electrode to specification:** Yes No N/A**Weld Procedures Followed:** Yes No N/A**Qualified Welders:** Yes No N/A**Verified Joint Fit-up:** Yes No N/A**Approved Drawings:** Yes No N/A**Approved WPS:** Yes No N/A**Delayed / Cancelled:** Yes No N/A**Bridge No:** 34-0006**Component:** OBG**Summary of Items Observed:**

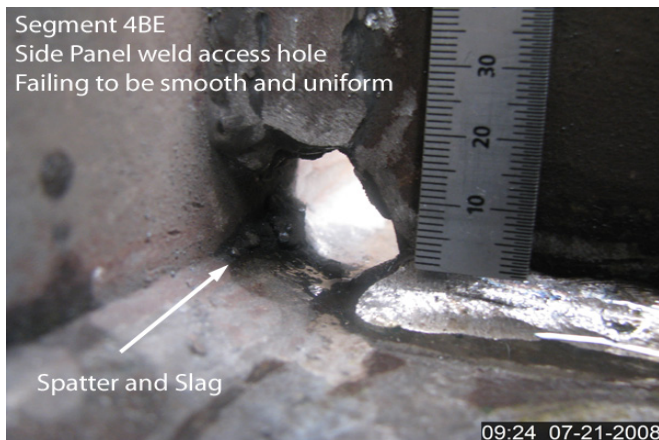
Segment 4BE – The Quality Assurance Inspector observed ZPMC in the process of fitting up Longitudinal Diaphragm Plate LD-003-004. The Quality Assurance Inspector observed numerous weld access holes on side panels failing to be smooth and uniform as required by AWS D1.5 2002. Below is a digital photograph illustrating the discontinuity.
